# Aestiva Ventilation Mode Selector Switch Failures

We describe three cases of previously unreported failures of the Bag-Ventilator Switch in Aestiva®/5 anesthesia machines (GE Healthcare/Datex-Ohmeda, Madison, WI). Each failure mode produced a large breathing-circuit leak. Examination of the switches revealed a cracked toggle actuator, residue build-up, and a cracked selector switch housing as causes for the failures. When a leak with no visible cause develops, consider advancing the mode selector switch fully to its mechanical limit or consider that the toggle actuator or its anchoring mechanism may have failed. These cases demonstrate that it is imperative to always be prepared to immediately use an alternate method for ventilation. Cases describing failure to ventilate due to sudden equipment malfunction underscore the need to always have functioning backup ventilation equipment available.

(Anesth Analg 2007;104:860-2)

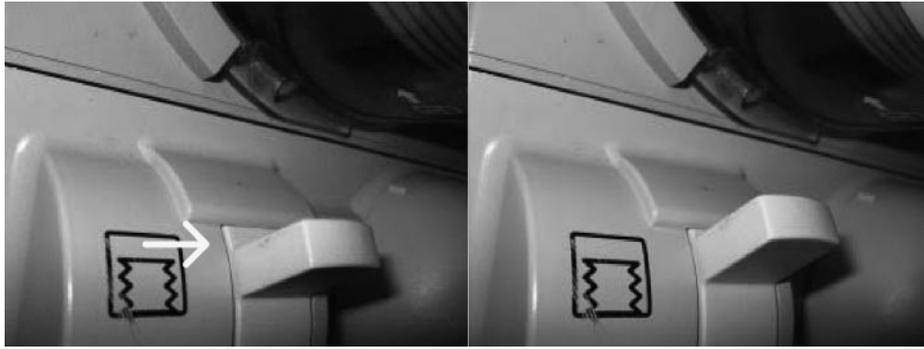
**Figure 1.** View (from above and left) of the absorber housing and the Bag-Ventilator switch short of its mechanical limit (arrow in left picture) and at its mechanical limit (right picture). From the typical perspective of an anesthesia provider, the difference in selector switch position will be less noticeable.

Two actions occur when the selector switch lever is toggled from the bag to the ventilator position in the Aestiva: 1) the ventilator is turned on (ventilator actuation does not appear to require the lever to be at its mechanical limit), 2) the manual ventilation sub-system, including the reservoir bag, is isolated from the breathing circuit. (This action requires the lever to be fully engaged.)

1. Attempt to advance the selector switch all the way to the mechanical limit of ventilator (or bag) mode position
2. Flip the selector switch to bag and attempt manual ventilation
3. Convert to ventilating with a self-inflating manual resuscitator
4. Provide alternate means of mechanical ventilation (spare anesthesia machine, transport, or intensive care unit ventilator)
5. Have the machine’s selector switch examined by qualified/authorized service personnel as soon as possible.

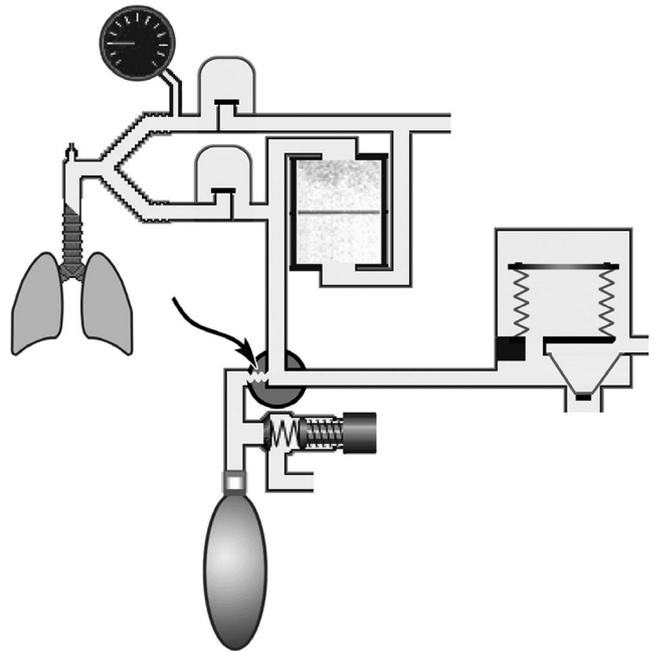
The effect of each of the three different selector switch failure modes (cracked toggle actuator, residue build-up, cracked selector switch housing) reported here was that, when toggled from bag to ventilator mode, the selector switch assembly did not completely seal off the manual ventilation sub-system. Thus, the faulty Bag-Ventilator selector switch produced a three-way connection among the breathing circuit, mechanical ventilation, and manual ventilation sub-systems (Fig. 2). This resulted in a significant amount of gas loss during mechanical ventilation through the partially open Bag-Ventilator selector valve.

**Figure 2.** A stylized representation of the leak between the manual and mechanical ventilation sub-systems that occurs only when the failed selector switch is in the mechanical position. Based on the Virtual Anesthesia Machine (VAM) simulation <http://vam.anest.ufl.edu> (with permission from the VAM authors).
